## **BUILDING DEPARTMENT**

**TOWN OF GILMANTON**

**November 12 2021**

**Re: Gilmanton Transfer station**

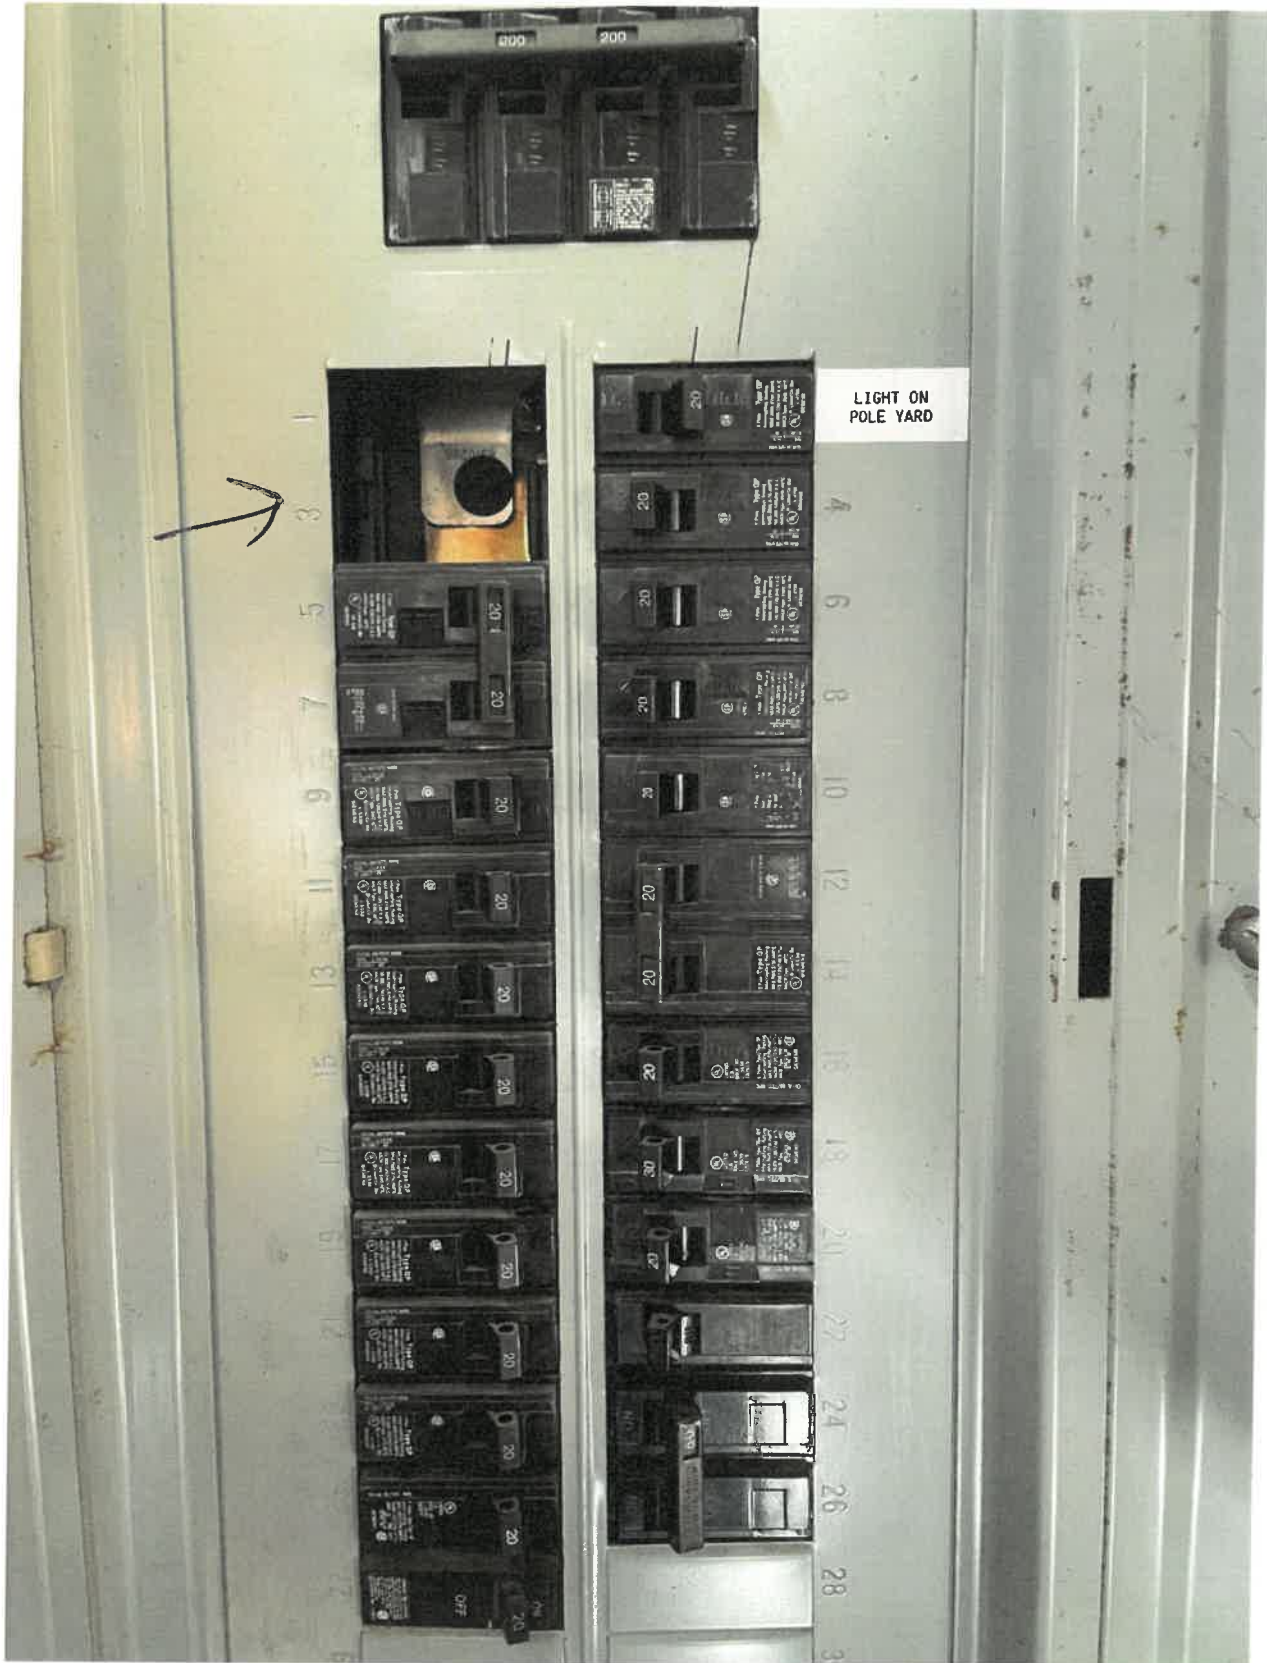
**Electric circuits are overloaded throughout. Many circuits have outlet strips in use, feeding multiple electrical fixtures, extension cords, including several electric heaters. Electric heaters appear to be the main, or only heating source for the facility. The main panel for the building has open slots which exposes an electrified bus bar, a personnel safety hazard. The panel was also behind an awkward fence gate that was also obstructed by debris. The panel labeling is either incomplete or inaccurate. There are areas of electrical wiring that appear to have not been professionally installed.**

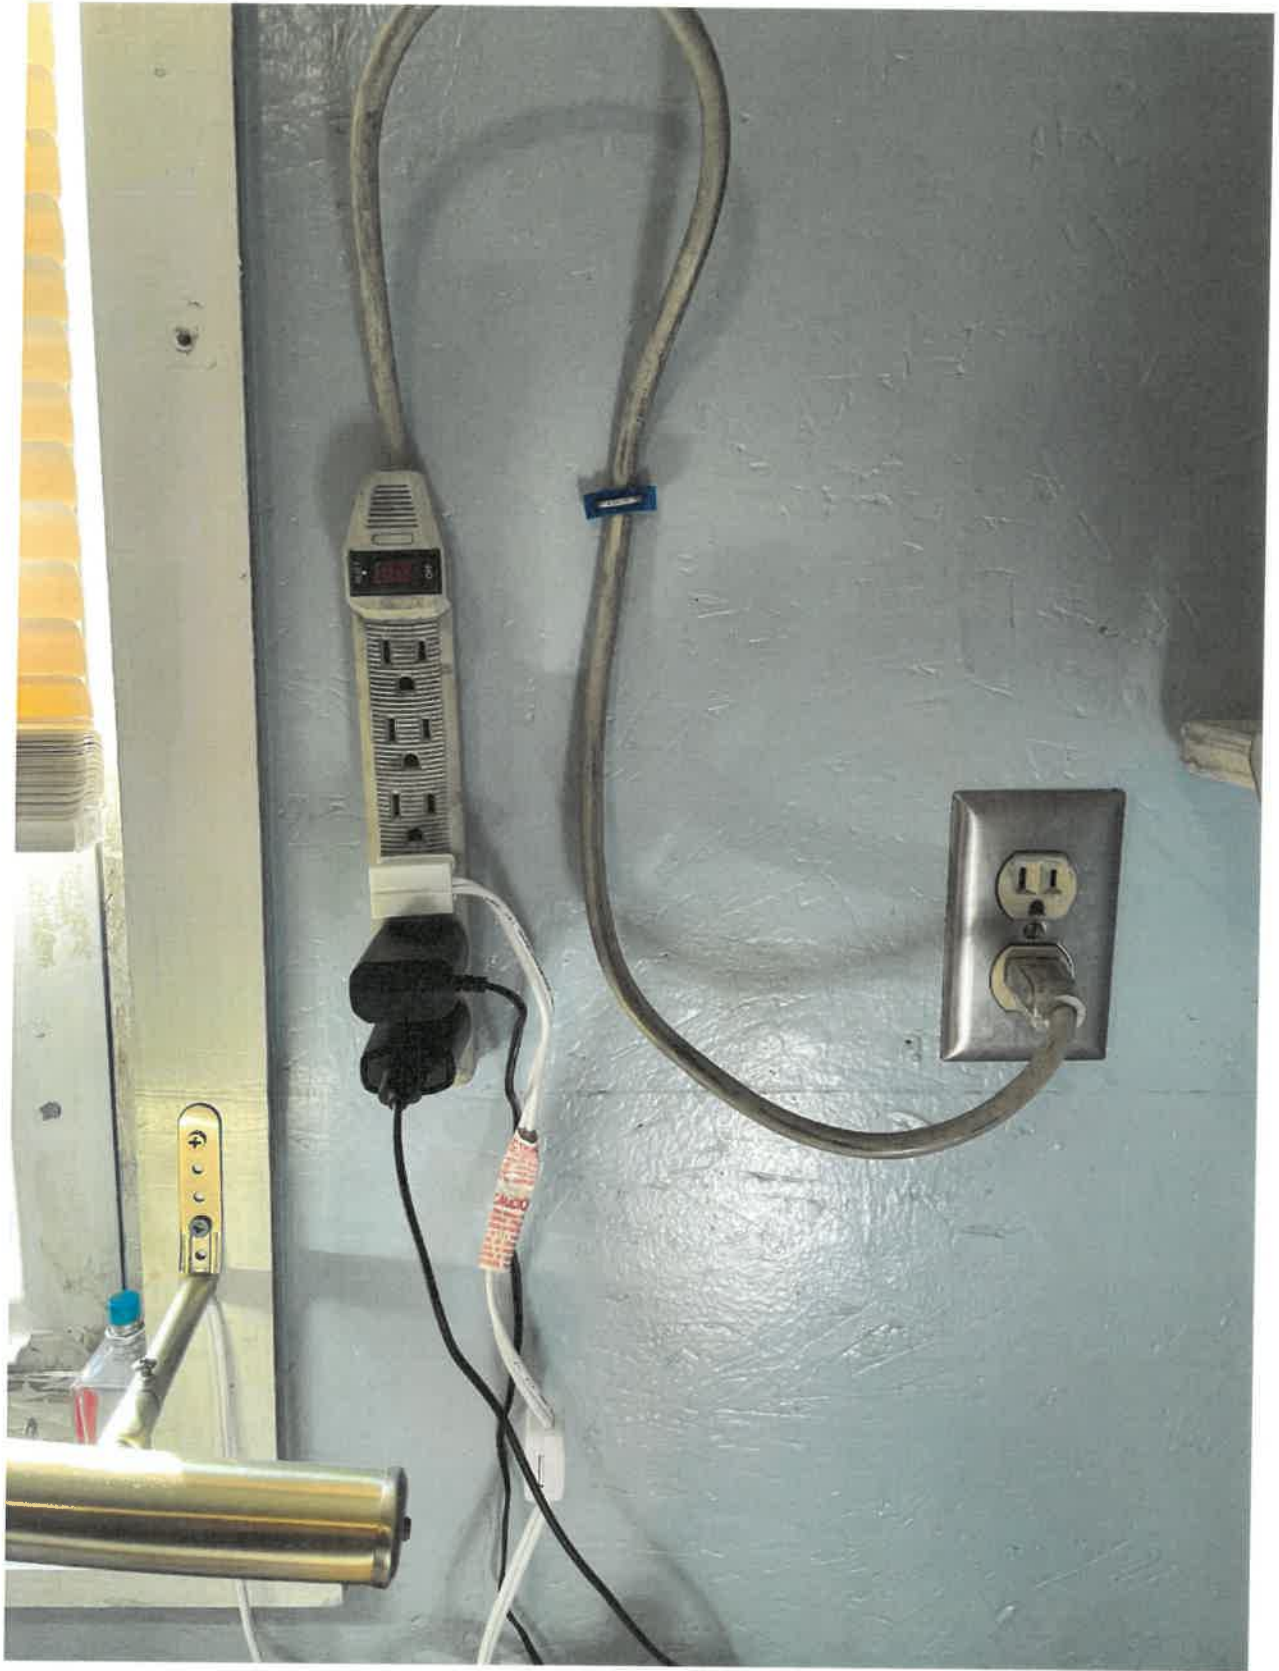
Labeling incomplete

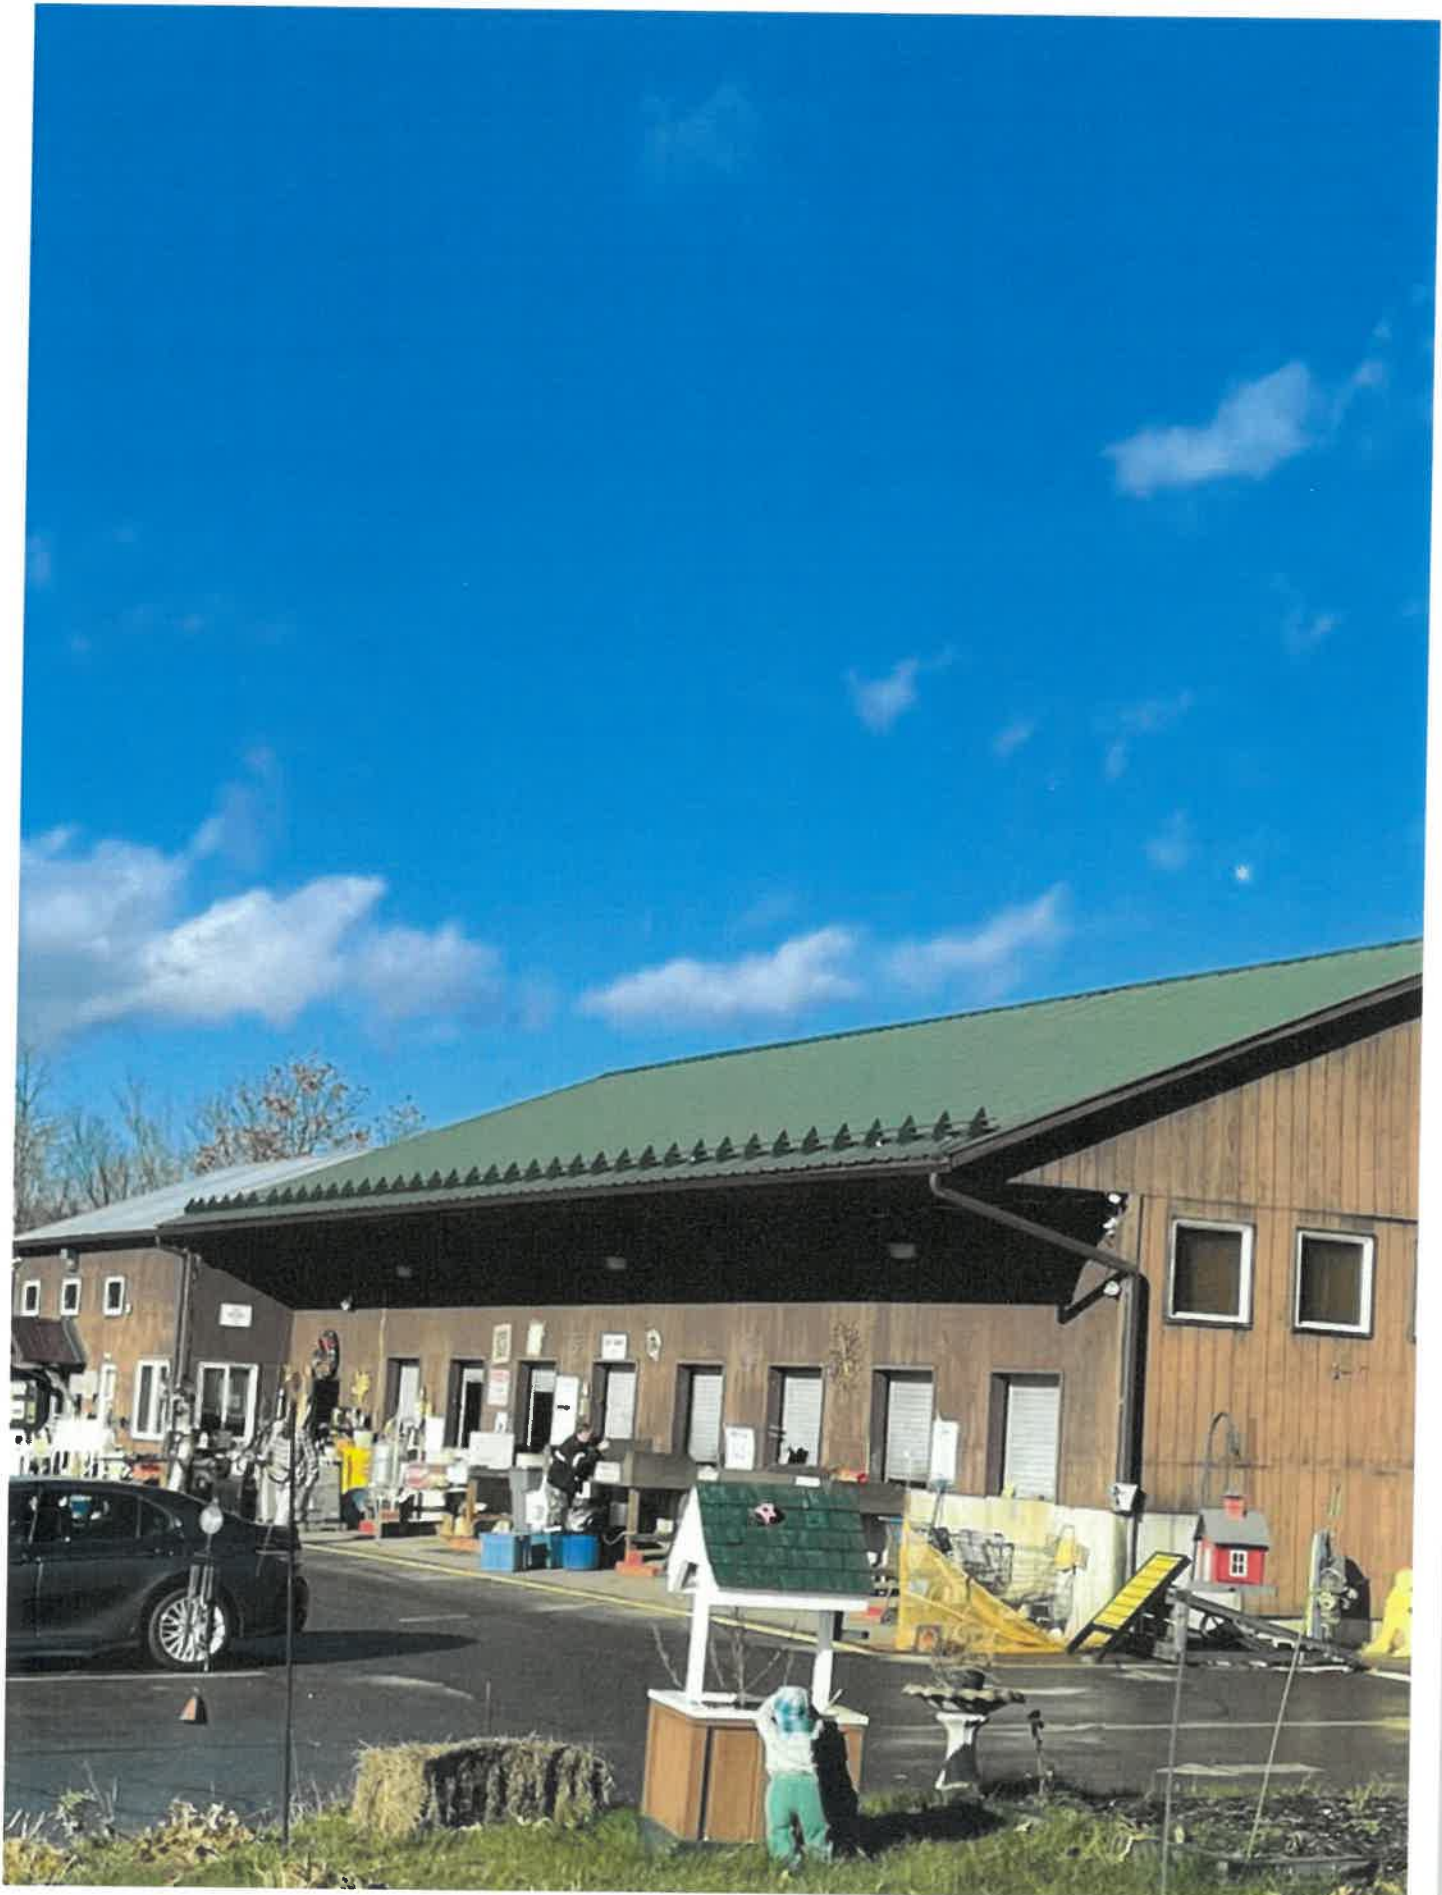
**My immediate impression was the entire facility was in dire need of housekeeping. Various Egress and access points to the facility are in disarray and partially blocked with varying debris / items. Also, access to critical functions of the facilities electrical panel, disconnects, fire extinguishers bathroom etc. are either fully or partially blocked and not easily accessible.**

Entrance to electric panel
