Town of Gilmanton Old Town Hall

1800 NH 140, Gilmanton Iron Works

Level II Energy Audit

August 23, 2021

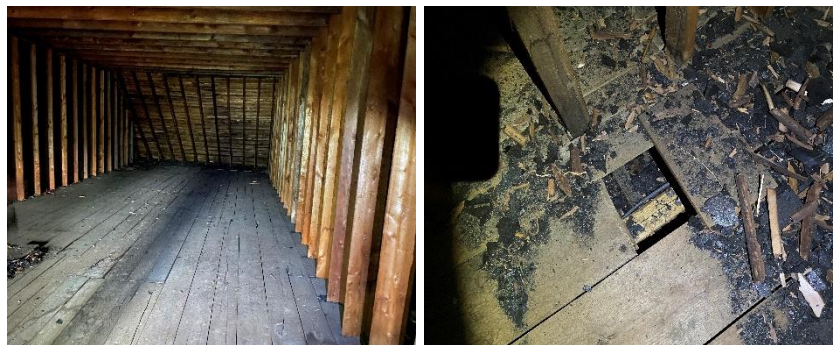
- **B2: Insulate Attic.** The attic is currently uninsulated and presents an excellent opportunity to install new insulation and reduce heat loss through this space. The floor of the former Odd Fellows Hall below the attic (pictured at right) is the current thermal boundary in order to reduce the heated volume. Should the Odd

Figure 1. Uninsulated attic proper

Fellows Hall return to useable, function space RBG recommends insulating the true attic to at least R60.

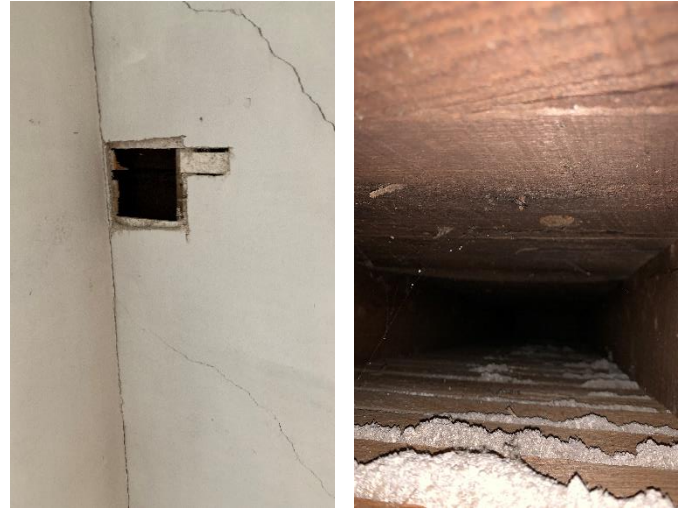
- **B3: Insulate Walls.** There is evidence of cellulose insulation in the crawlspace, which suggests an attempt was made to insulate the walls, however some walls appear completely empty. Since the clapboards are scheduled to be scraped, repaired, and painted, now would be a good opportunity to remove a row of clapboards above and below windows on both floors and install dense pack cellulose in the wall cavities. This will improve the thermal resistance of the walls as well as provide an air sealing benefit.

Figure 2. Uninsulated wall cavity
