Town of Gilmanton Iron Works Fire Department

1824 NH 140, Gilmanton Iron Works

Level II Energy Audit

August 23, 2021

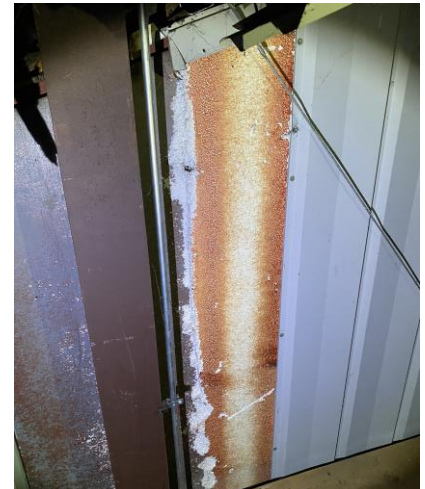
- **Number of Levels:** Two
- **Foundation and Insulation:** The foundation is poured concrete, slab-on-grade.
- **Exterior Wall Construction and Insulation:** The exterior walls are constructed of metal studs with metal siding. The exterior walls of the garage bays are insulated with 1" polystyrene rigid insulation. The exterior walls of the rear addition (offices and dormitory) are insulated with 2" fiberglass batt, vinyl wrapped insulation with a thermal resistance of r-19.

Figure 1. Exterior insulation of garage

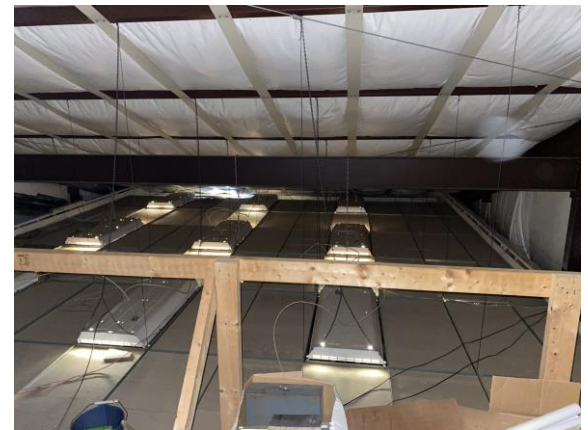
- **Roof Type and Insulation:** The roof over both sections of the building is metal frame with corrugated metal panels. The roof is insulated with 6" fiberglass batt, vinyl wrapped insulation.

Figure 2. Roof insulation above dormitory

- **B1: Air Sealing.** The penetrations through the roof above the dormitory and the between the dormitory attic storage space and the roof system of the front bays should be sealed. We recommend continued weather-stripping maintenance to all exterior doors and windows, along with other shell penetrations to prevent infiltration. This should be recognized as an annual maintenance task, as continual maintenance of weather stripping is needed on high-use doors.
- **B2: Spray foam attic and garage roof.** The storage attic roof and garage roof is insulated with R19 fiberglass batt insulation. RBG recommends installing 3” of closed cell spray foam on the underside of garage roof and apply intumescent paint. This will increase the total R-value to R-40.

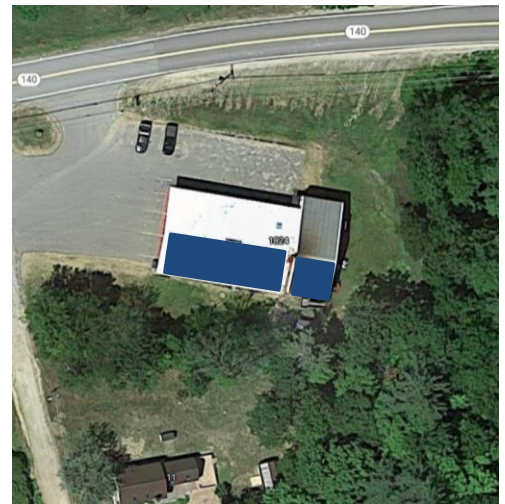
Figure 4. Proposed PV array

- **R1: Photovoltaic Array.** Install a roof-mounted 35 kW PV array on the building's roof. This array is projected to generate 45,080 kWh/year assuming the installation of high-efficiency panels. The building consumes an average of 37,015 kWh per year, which means the proposed PV system would generate approximately 120% of the building's average annual electric usage.

The cost and output of the PV Array is estimated using NREL's PVWatts calculator and project costs that RBG has been involved in. These numbers are strictly estimates.
