# Solid Waste Facility Inspection Report

A. GE	ENERAL INFORMATION
1. Facility Name: Gilmanton Transfer Station and Recycling Center	2. Date of Inspection: 4/24/2023
3. Permittee Name: Town of Gilmanton	4. Nature of Inspection: ☐ Routine ☐ Re-inspection ☒ Requested ☐ Complaint
5. Permit #: DES-SW-PN-00-011	6. Scope of Inspection: ⊠ Full □ Limited - Sections Inspected:
7. Facility Location: 284 Province Rd Gilmanton NH 03237	
8. Inspector(s): Austin Mills	
9. Attendees: Heather Carpenter – Town of Gilmanton Town Administ	trator, Peter Kotsakis – Town of Gilmanton
10. Open enforcement actions at the facility? ☐ Yes ☒ No	
11. List of Cer	rtified Solid Waste Operators:
Name:	Date of Expiration:
Peter Kotsakis	8/21/2023

## Attachment A – Photograph Log

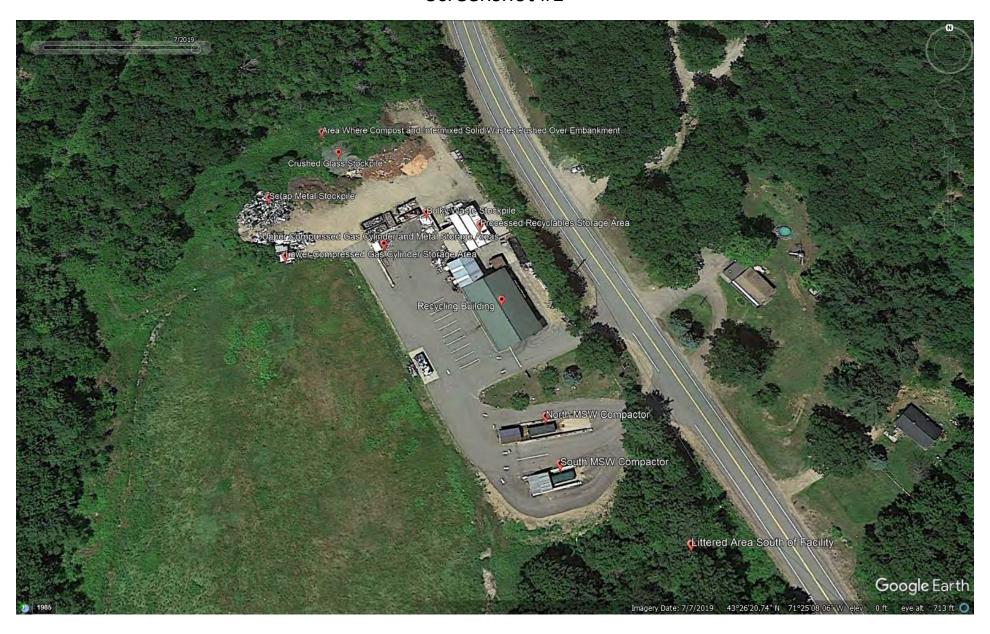
#### Screenshot #1

Photograph Information				
Date of Photographs	4/24/2023 & 4	4/24/2023 & 4/27/2023 Photographer Austin Mills		Austin Mills
Camera Used	iPhone SE			
Photograph Number		Description		
IMG_1946 (Taken 4/2	27/2023)	Facility entrance sign	gnage	
		Al	l photographs belo	w taken 4/24/2023
Screenshot #1	L	7/2019 satellite im	age of facility layou	ut
IMG_1871		Litter in forested ar	ea south of facility	,
IMG_1872		Litter in forested ar	ea south of facility	'
IMG_1873		Litter in forested ar	ea south of facility	,
IMG_1874		Litter in forested ar	ea south of facility	,
IMG_1875		Litter captured by s	south-side facility f	ence
IMG_1876		View looking north	into facility prior t	o being granted access
IMG_1877		View looking west	into facility prior to	being granted access

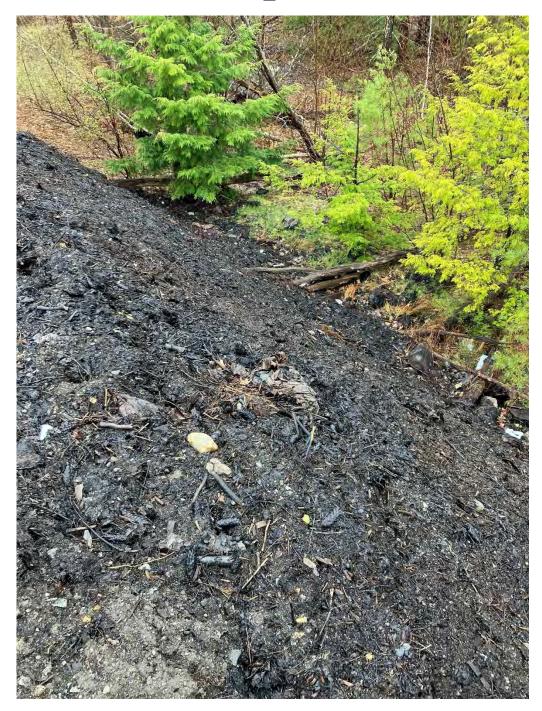
IMG\_1917

IMG_1916	Compost and intermixed solid waste stockpile looking down the slope towards the northwest
IMG_1917	Compost stockpile looking west (no identified intermixed solid wastes)
IMG_1918	Compost and intermixed solid waste upper stockpile looking southwest
IMG_1919	Compost and intermixed solid waste stockpile slope stability issues looking west
IMG_1920	Crushed glass stockpile looking east
IMG_1921	Partially dismantled transfer container near crushed glass stockpile looking northwest

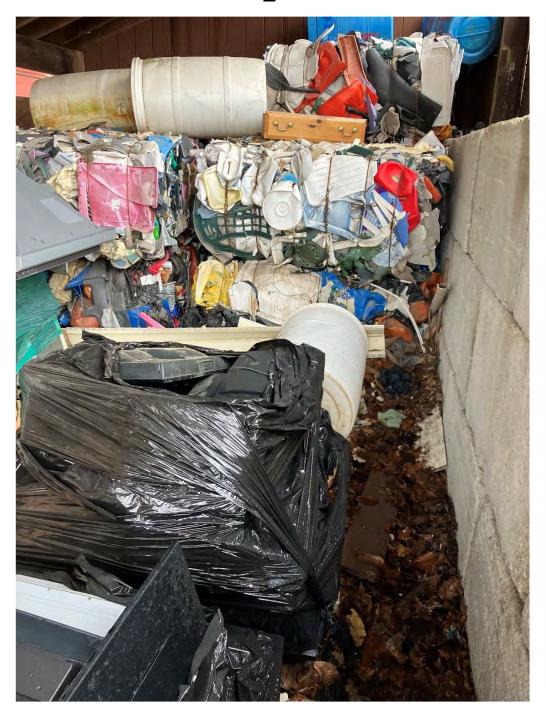
IMG\_1932

IMG_1922	Crushed glass stockpile looking north
IMG_1923	Litter and compost with intermixed solid wastes near crushed glass stockpile looking north
IMG_1924	Litter and drums looking south towards loading dock on east side of recycling building
IMG_1925	Litter at fence near east side of loading dock area
IMG_1926	Batteries stored and CRT stored on north side of recycling building
IMG_1927	1lb compressed gas cylinders and electronics/wires stored on north side of recycling building
IMG_1928	Pallets, televisions, baled plastics, drums and broken glass stored on north side of recycling building
IMG_1929	Televisions and other electronics stored on north side of recycling building
IMG_1930	Televisions and other electronics, baled plastics and drums stored on north side of recycling building
IMG_1931	Roof covering of north side of recycling building
IMG_1932	Bulky waste and C&D transfer container
IMG_1933	Bulky waste and C&D transfer container

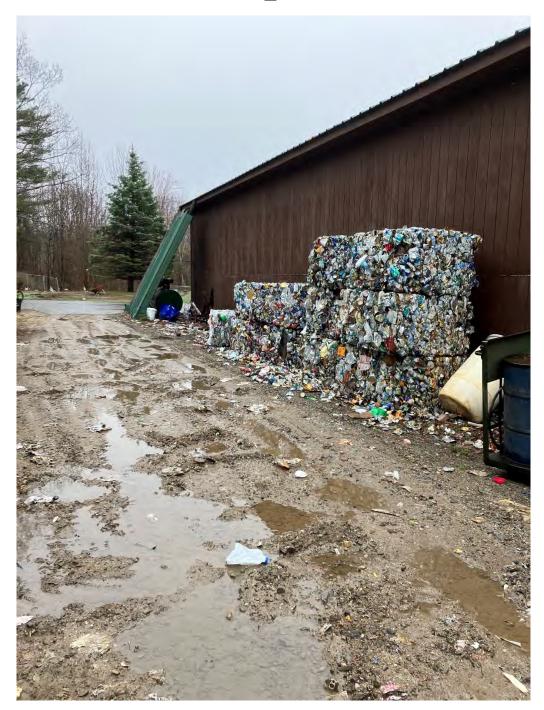
IMG\_1945

IMG_1944	Steel can bales stockpiled behind east side of recycling building
IMG_1945	Contents of flammable cabinet to the north of the recycling building
