Gilmanton Energy Audit Summary Page

Town of Gilmanton Iron Works Fire Department

Level II Energy Audit

Prepared by: *Resilient Buildings Group, Inc.*

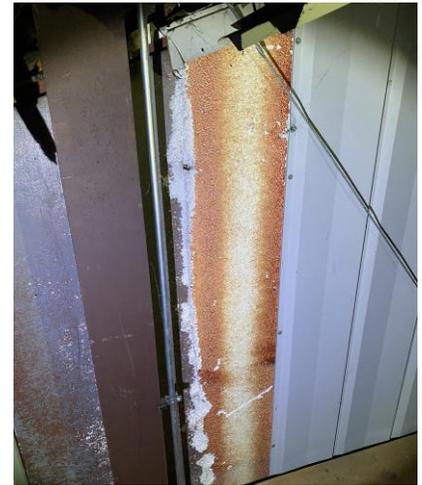
Figure 1. Exterior insulation of garage

- **Number of Levels:** Two
- **Foundation and Insulation:** The foundation is poured concrete, slab-on-grade.
- **Exterior Wall Construction and Insulation:** The exterior walls are constructed of metal studs with metal siding. The exterior walls of the garage bays are insulated with 1” polystyrene rigid insulation. The exterior walls of the rear addition (offices and dormitory) are insulated with 2” fiberglass batt, vinyl wrapped insulation with a thermal resistance of r-19.

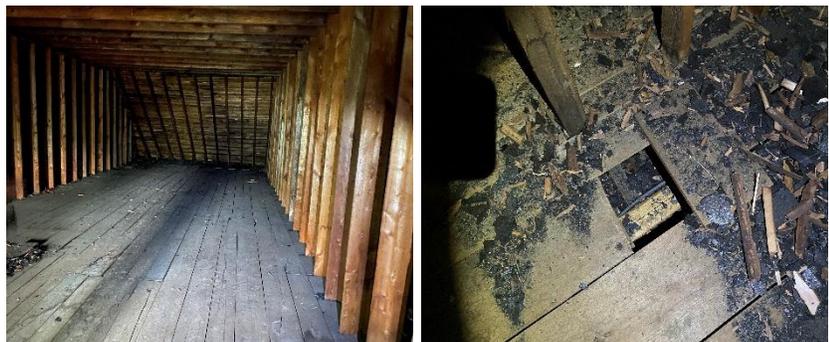
Figure 1. Uninsulated attic proper

- **B2: Insulate Attic.** The attic is currently uninsulated and presents an excellent opportunity to install new insulation and reduce heat loss through this space. The floor of the former Odd Fellows Hall below the attic (pictured at right) is the current thermal boundary in order to reduce the heated volume. Should the Odd

Fellows Hall return to useable, function space RBG recommends insulating the true attic to at least R60.

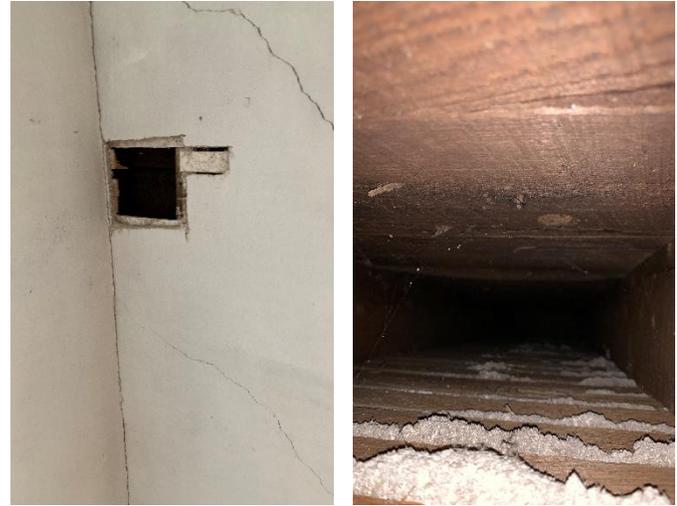
Figure 2. Uninsulated wall cavity

- **B3: Insulate Walls.** There is evidence of cellulose insulation in the crawlspace, which suggests an attempt was made to insulate the walls, however some walls appear completely empty. Since the clapboards are scheduled to be scraped, repaired, and painted, now would be a good opportunity to remove a row of clapboards above and below windows on both floors and install dense pack cellulose in the wall cavities. This will improve the thermal resistance of the walls as well as provide an air sealing benefit.
