## **BUILDING DEPARTMENT**

**TOWN OF GILMANTON**

**November 12 2021**

**Re: Gilmanton Transfer station**

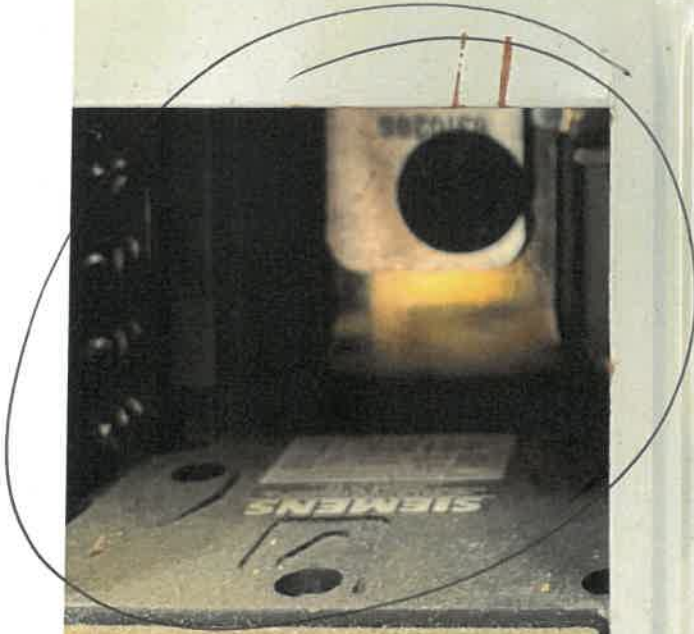
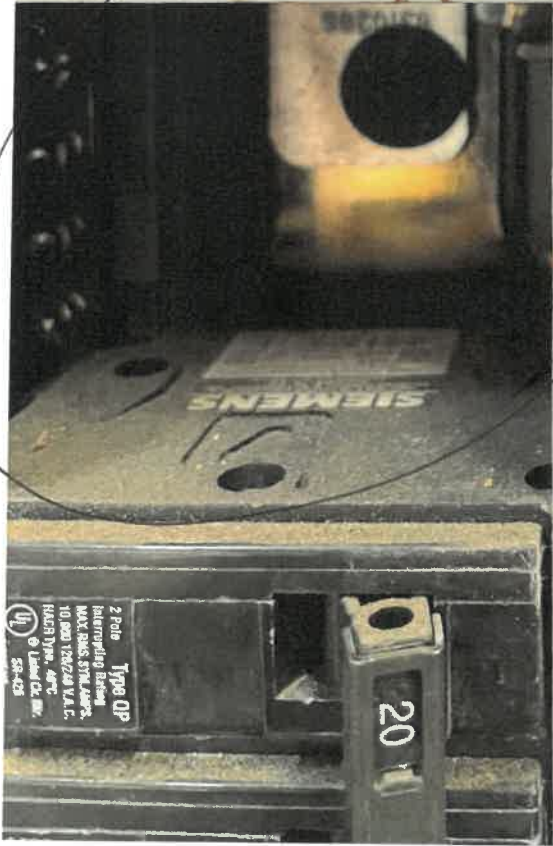
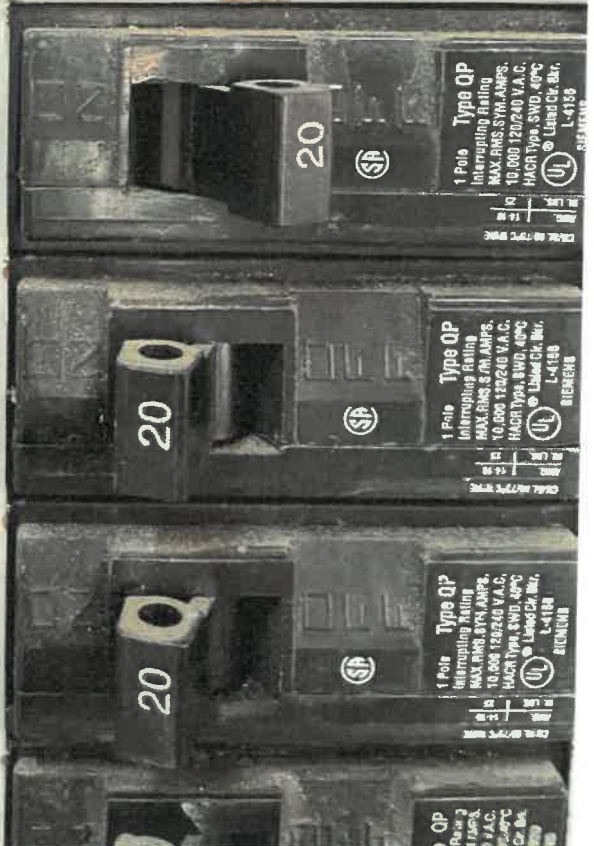
**Electric circuits are overloaded throughout. Many circuits have outlet strips in use, feeding multiple electrical fixtures, extension cords, including several electric heaters. Electric heaters appear to be the main, or only heating source for the facility. The main panel for the building has open slots which exposes an electrified bus bar, a personnel safety hazard. The panel was also behind an awkward fence gate that was also obstructed by debris. The panel labeling is either incomplete or inaccurate. There are areas of electrical wiring that appear to have not been professionally installed.**
